# ATM Technology Demonstration 1 (ATD-1)

## EcoDemonstrator ASTAR Guided Arrival Research (EAGAR)

Roy Roper  
Project Outbrief  
January 29, 2015

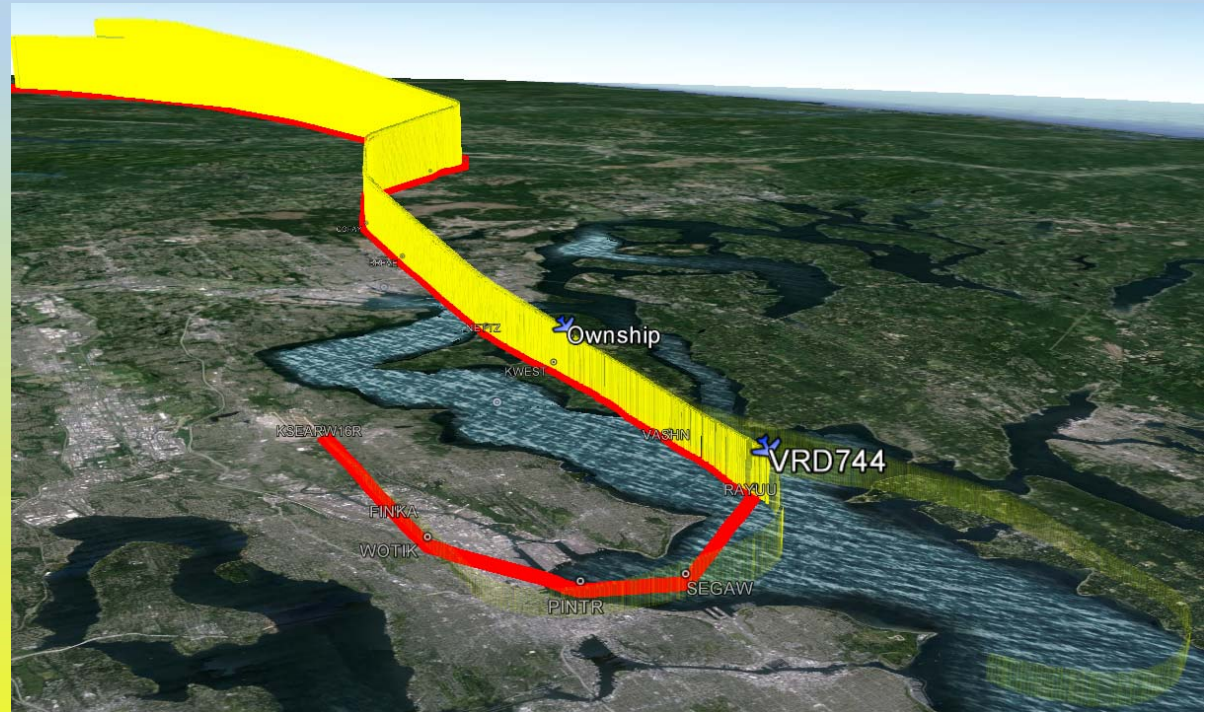
# Dec. 6 Concurrent Testing

IM Ops conducted over 64 nmi (77→13 nmi from Rwy)  
~20 minutes

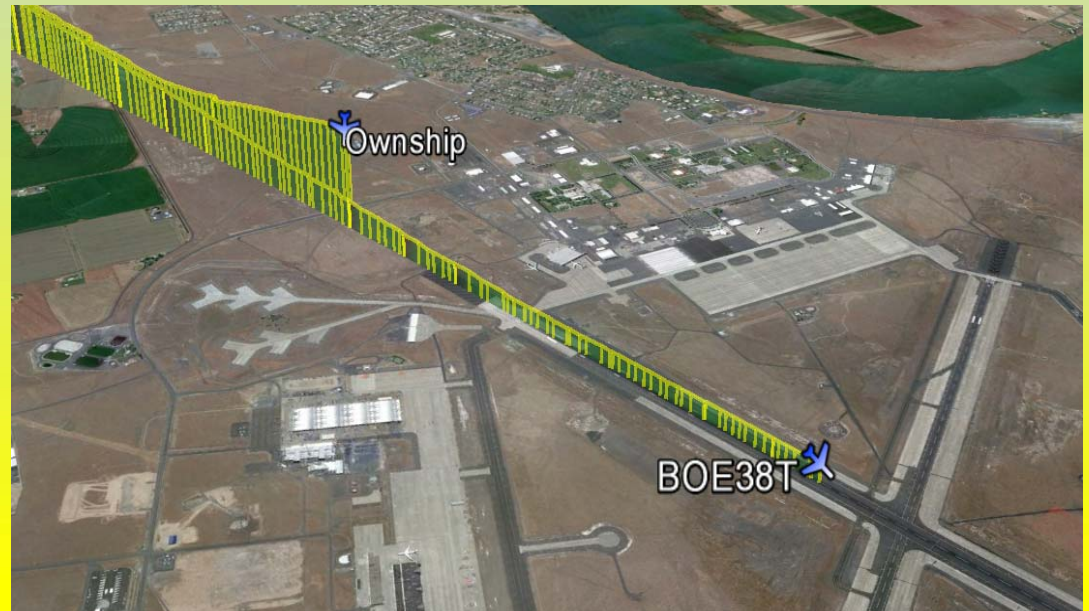
# Run 1

- 3 speed inversions
- 13 speed commands (1 command/1 min. 33 sec)
- B787 performed a go-around b/c T-38 was on runway

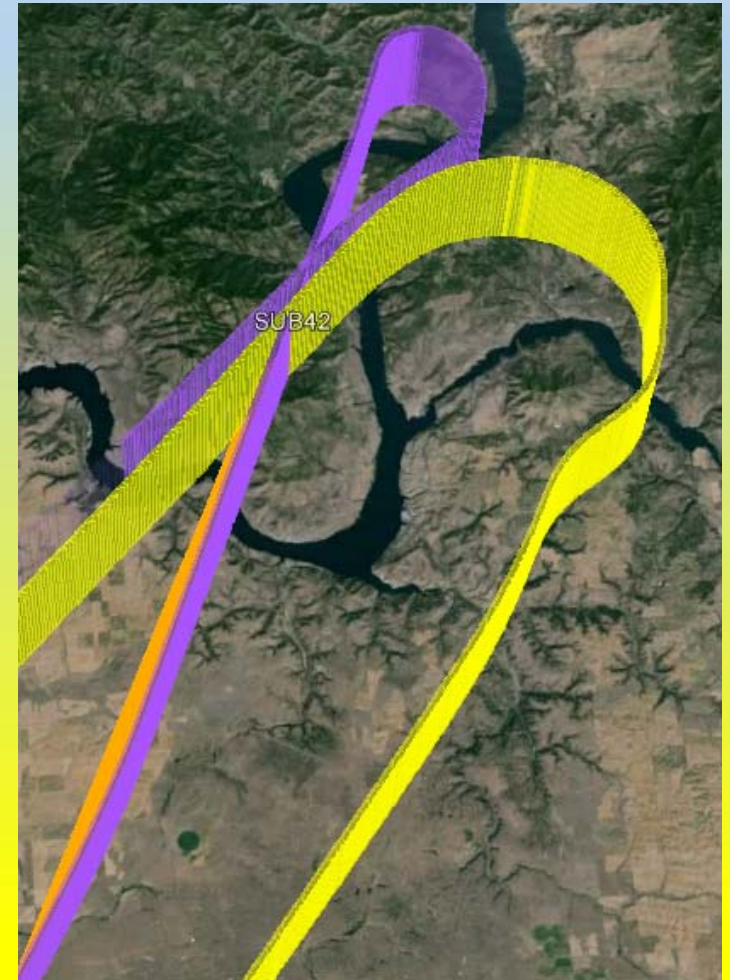
# Run 3

## Poor setup prior to run

- ASTAR on ~8 min. with no pairing
- OWNSHIP OFF PATH message
- Cockpit stated B787 was on path
- Paired 8 sec. prior to shutdown
- 6.14 nm separation at shutdown
